Corrosion of Low Carbon Steel in Chloride Containing Environment

Pornpibunsompob, T.; Saidarasamoot, S.; Phabjanda, S.; Pornyungyuen, T.; Gositanon, A.; Chalermboon, S.; Nakaracha, P. Corrosion of Low Carbon Steel in Chloride Containing Environment. *ASEAN J. Sci. Tech. Report.* **2022**, *25*(4), 21-29. <https://doi.org/10.55164/ajstr.v25i4.247174>.

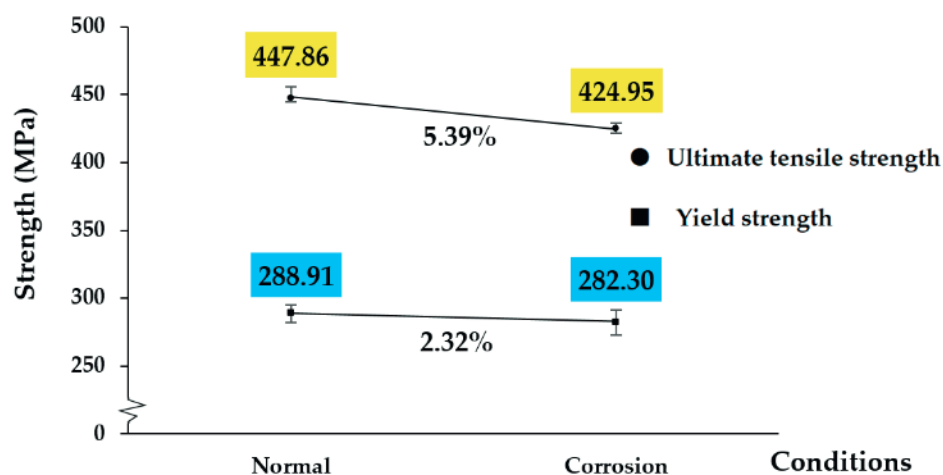
It was found that normal specimens have an average maximum tensile strength of 447.86 MPa, which is higher than that of corroded specimens with an average maximum tensile strength of 424.95 MPa. In the same way, the average yield strength of normal specimens is 288.91 MPa, while the average yield strength of corroded specimens is 282.30 MPa. Therefore, the average mechanical properties of normal specimens are higher than those of corroded specimens, as shown in Figure 3. If it is calculated as a percentage, it will be concluded that normal specimens have the average maximum tensile strength and the average yield strength higher than corroded specimens at 5.39% and 2.32%, respectively. Because the surface of corroded specimens is very rough due to corrosion products, tension loads acting on the corrosion pits will cause stress concentration and decrease the strength[8]. When the workpiece is subjected to tensile stress, it is easier to propagate some cracks. It can be noticed from the cracked surface, and it is a sharp tooth mark, as shown in Figure 4(A). When the tensile strength increases, the crack will propagate until the workpiece is completely fractured. While normal specimens do not have corrosion products on the surface, the fracture is caused by the ductile failure mechanism. The fracture surface is shown in Figure 4(B). Thus, it has a strength higher than the corroded workpiece.

Figure 3. Average mechanical properties comparison between normal and corroded specimen

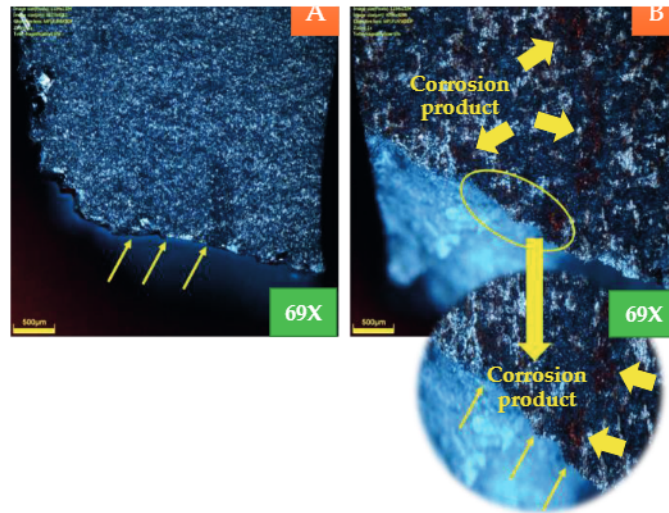
Figure 4. Fracture surface analyzed by optical microscope comparison between (A) Normal specimen and (B) Corroded specimen

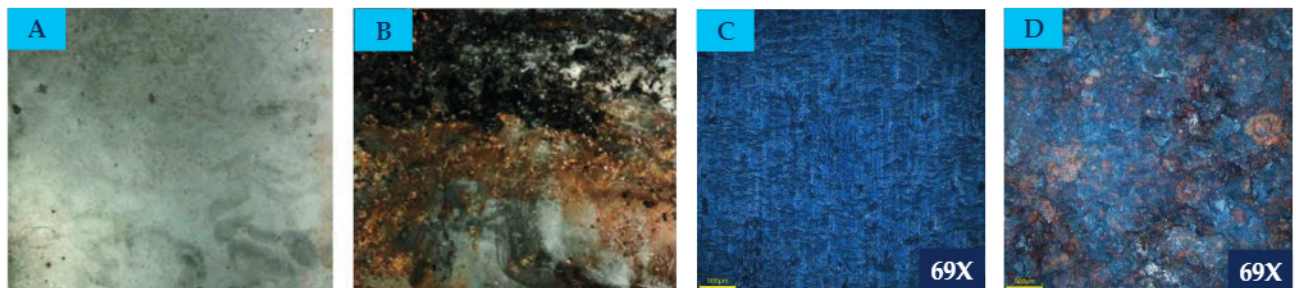
The surface condition of normal and corroded specimens, observed with visual and light microscopy, is shown in Figure 5. It can be seen that the normal specimens' surface is matte and does not peel off. As for the corroded workpiece, the surface of the workpiece is rough, and some area of the specimen's surface is peeled off. Also, it is found corrosion products when examined by scanning electron microscopy. As shown in Figure 6, it was found that the surface of the normal specimen is smooth and dull. Small scabs may be found on the surface in some places resulting from the hot rolling process. As for corroded parts, the workpiece's surface is rough and peeled off.

Figure 5. Surface investigation of specimens by visual examination (A) normal specimen, (B) corrosion specimen, and by optical microscope (C) normal specimen (D) corroded specimen

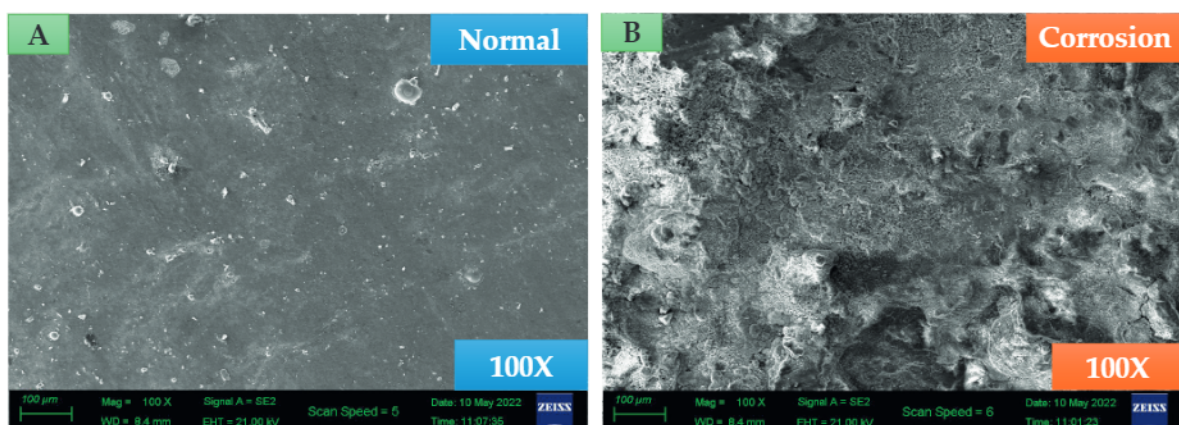
Figure 6. Surface morphology analyzed by FESEM (A) normal specimen (B) corroded specimen

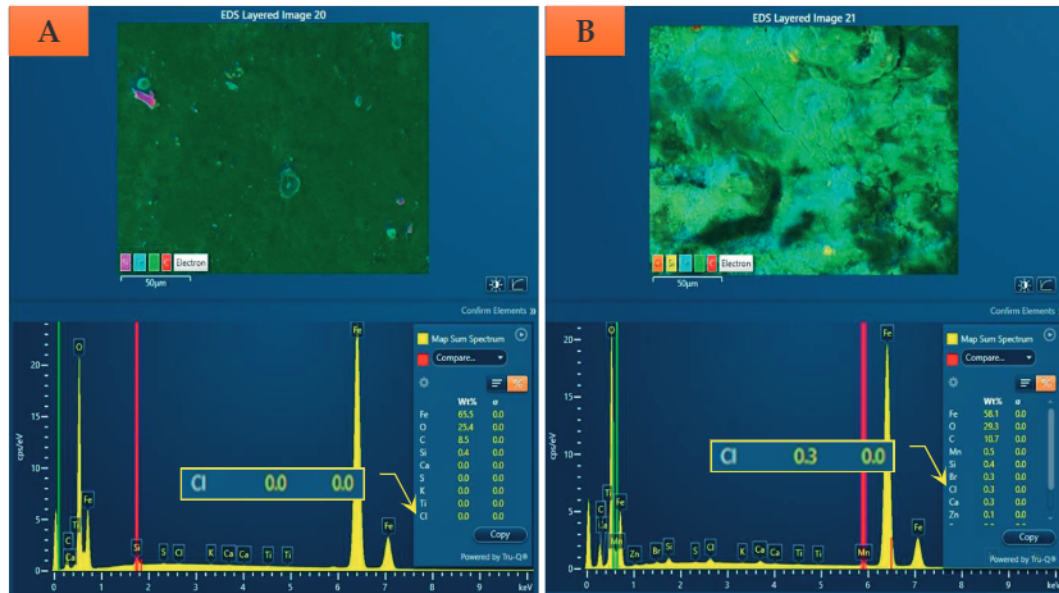
The microchemical composition examined by EDS is depicted in Figure 7. It shows that the normal surface of the specimen is composed of iron, oxygen, carbon, and silicon, while the surface of the corroded specimen contains the same elements as the normal specimen except chlorine. It was detected on the surface of the specimen. Chlorine is one of the main elements that potentially cause corrosion in steel [6]. The effect of chlorine on corrosion is studied next.

Figure 7. Microchemical composition of the specimen surface analyzed by EDS (A) Normal specimen (B) Corroded specimen

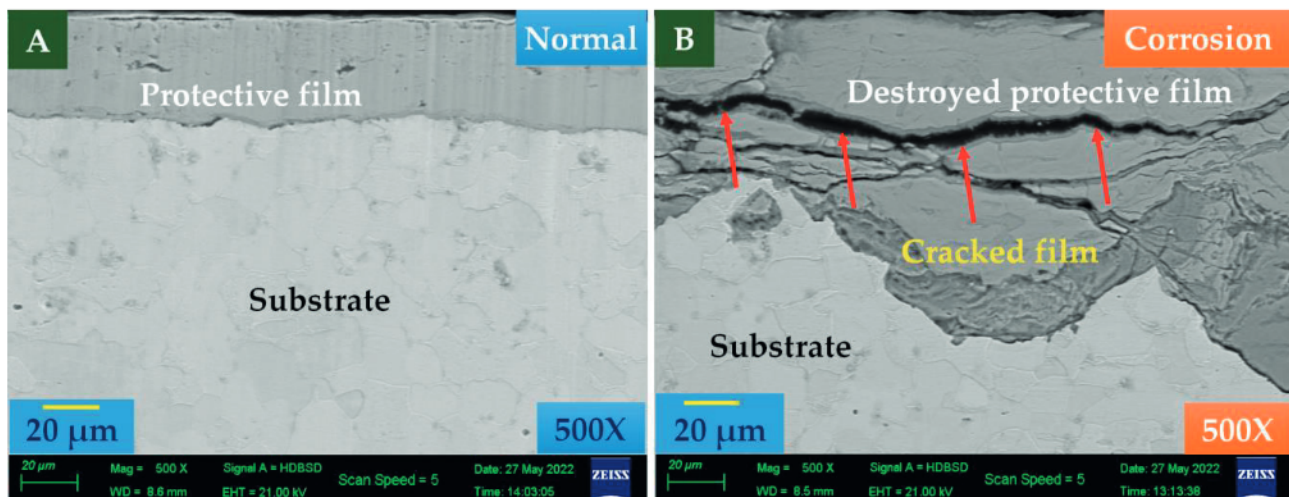
A detailed investigation of the surface, especially at the protective film, was performed, as shown in Figure 8. It was found that normal specimens have a protective film coating on the surface. An oxidation reaction formed the film layer during the hot rolling process (Figure 8(A)). In contrast with corroded specimens, the protective film is destroyed. The film contains several cracks separating the protective film from each other. This phenomenon allows the metal surface to contact the corrosive environment directly. Therefore, oxidation reactions still occur continuously. So, the film layer of the corroded specimen is not only a result of the hot rolling process, but it is also caused by an oxidation reaction when the substrate is exposed to the corrosive environment. That explanation can also explain why the film thickness of the corroded workpiece is greater than the normal specimen.

Figure 8. Morphology of protective film analyzed by FESEM (A) normal specimen (B) corroded specimen

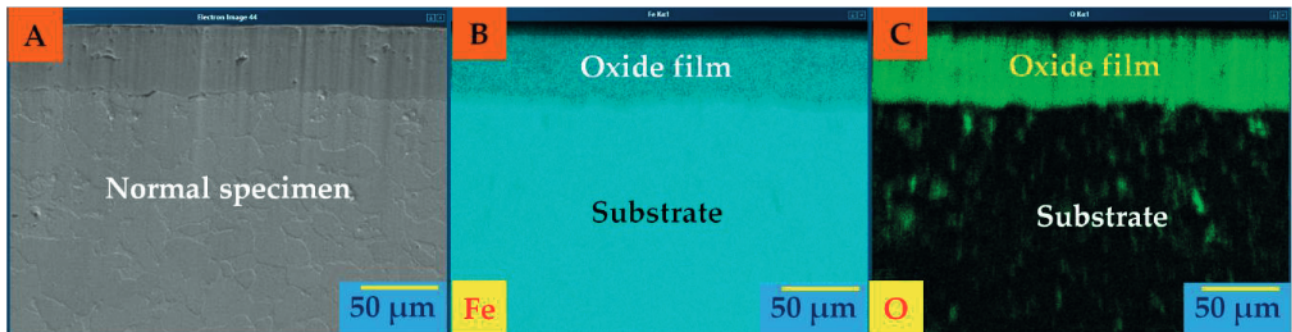
The microchemical composition of normal specimens is shown in Figure 9. It was found that the protective film formed by the hot-rolling process was mainly composed of iron and oxygen. It is ferrous oxide. Moreover, it was observed that the iron content in the oxide film region was greater than that in the substrate. The substrate is composed of many elements within it. Therefore, as a proportion, the iron content is greater in the film layer area.

Figure 9. EDS mapping of cross-section's surface normal specimen (A) SEM micrograph (B) iron (C) oxygen

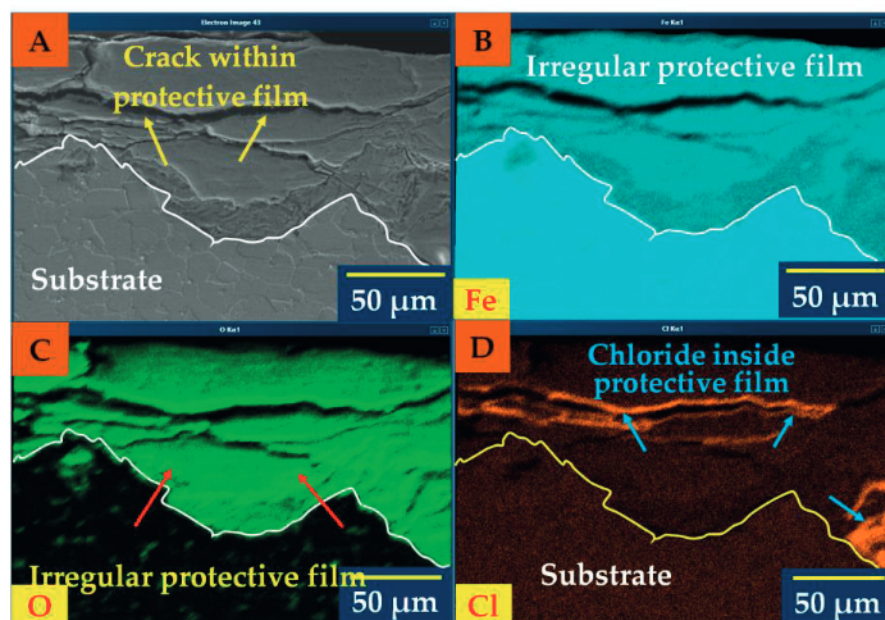
The oxide film layer is cracked in corroded specimens. However, the chemical composition is not quite similar to the normal specimens. Iron, oxygen, and chlorine are found in the oxide film. It remains similar to the composition of the corroded specimen's surface, as shown in Figure 10. Therefore, the oxidation of steel, despite the presence of chlorine, will continue to form compounds composed of iron and oxygen because the protective film is porous (Even though it has been hot rolled, making the film denser). This allows the chloride ions to easily pass through the film and react with the substrate resulting in a thicker and deeper oxidation film. However, if the oxidation layer is complete, it will inhibit chloride corrosion [6]. Chloride plays a vital role in catalyzing the oxidation of steel.

Figure 10. EDS mapping of cross-section's surface corroded specimen (A) SEM micrograph (B) Iron (C) Oxygen (D) Chlorine

Because the chloride ion catalyzes the oxidation reaction of steel, following Equations 1 – 2, resulting in an increment in both classification and quantity of corrosion product. This is consistent with the analysis results shown in Figure 10.

1. A suitable pre-treatment or surface coating on a bare carbon steel surface would help inhibit corrosion. It prevents the access of corrosive anions to the steel surface [10-12].
2. Avoiding direct exposure to chloride-containing atmospheres can suppress and prevent corrosion, even though low-carbon steel can be slightly corroded in the natural environment caused by humidity and dissolved oxygen [13-14].
